Coal Burner Condition and Estimated Remaining Life Evaluation - Intermountain Generating Station

Final Report

Energy & Environmental Research Corporation

August 15, 1990

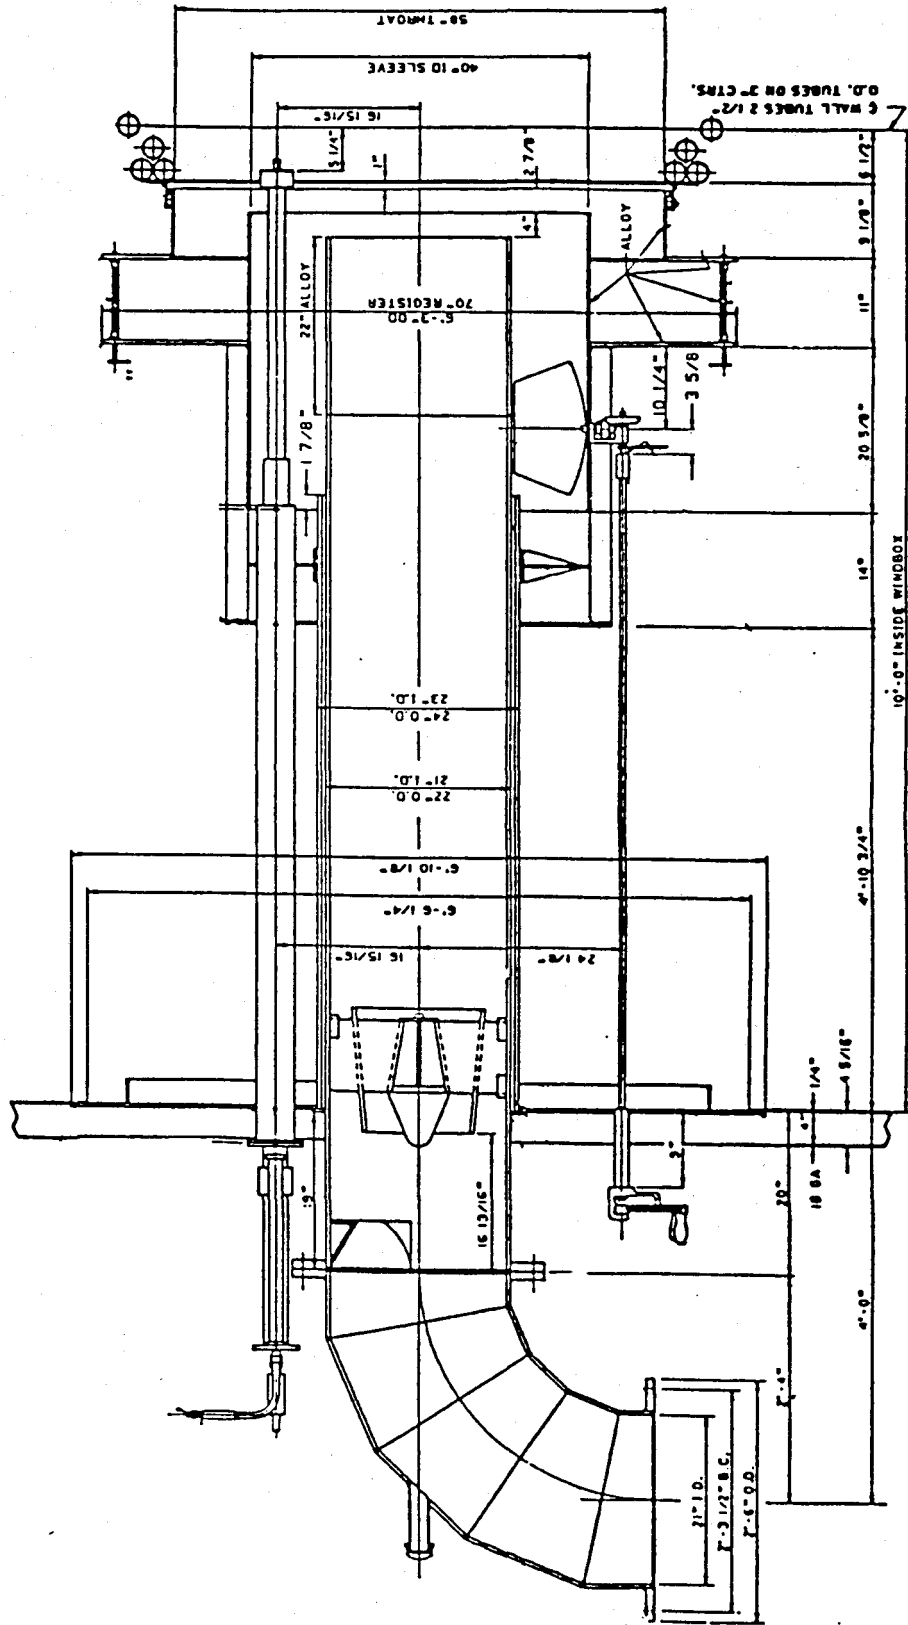
Figure 2

BABCOCK & WILCOX "HIGH INPUT" DUAL REGISTER BURNER

the design heat input and physical size were greater than all previous dual register burner applications. The H.D. type register replacement corrects some of the problems experienced with the original burner. The door shaft diameter has been increased from 1/2" to 3/4". The door shafts are fixed in place and the door rotates on the shaft. The linkage has been moved from behind the rear plate to the center of the register, and is not affected by the expansion of the rear plate. These changes have simplified the burner and have improved its operation.

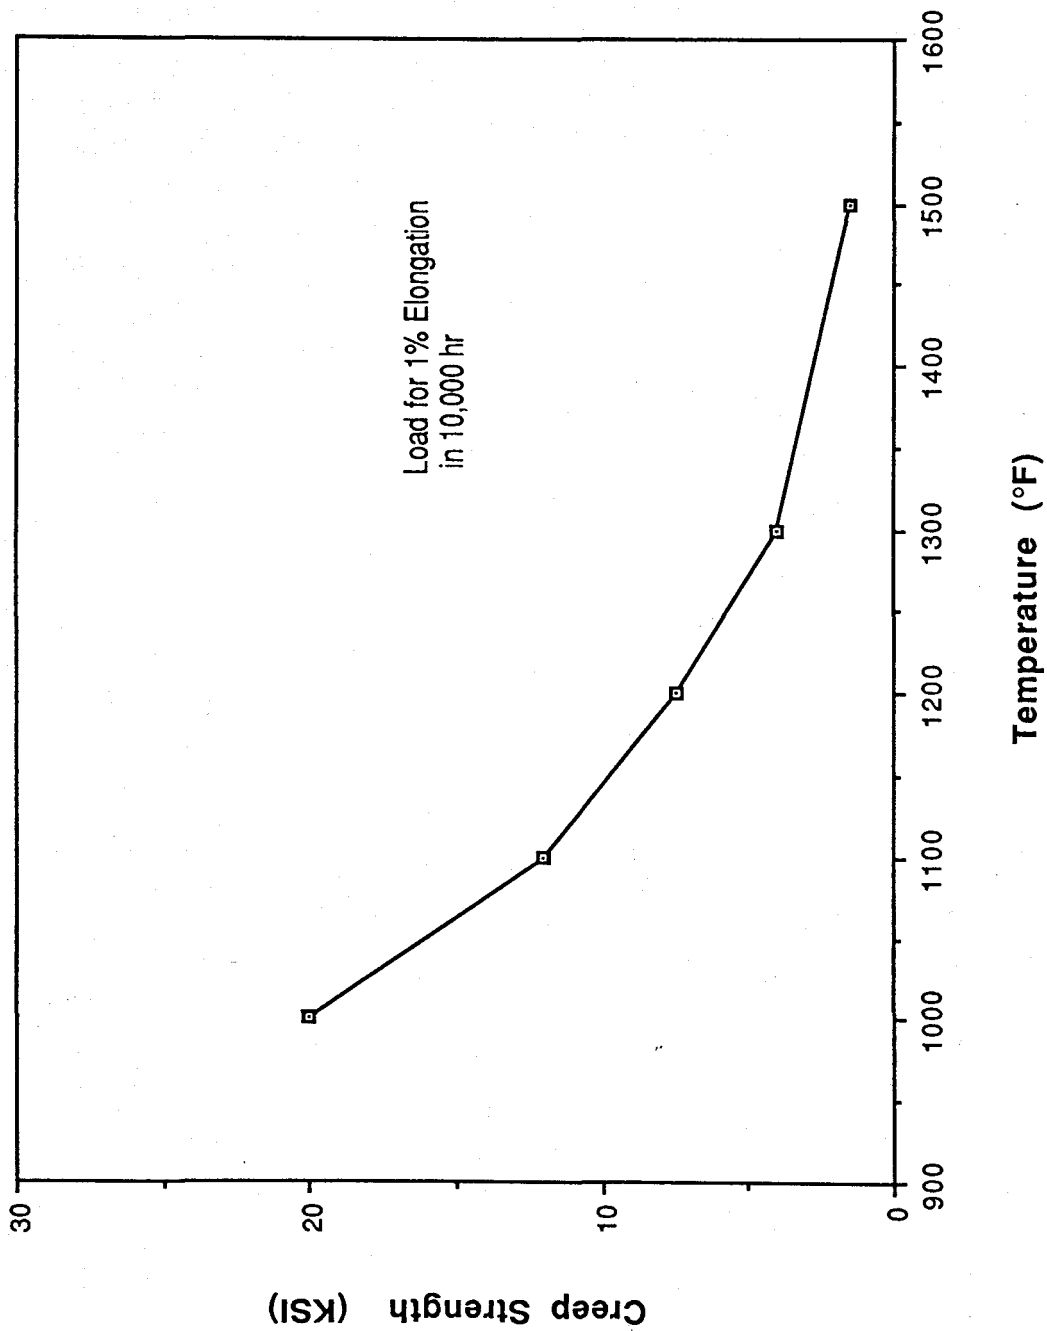
temperature under stress. Depending on the information source, the creep strength of AISI 304 stainless steel is reported as approximately 9.5 KSI at 1150°F and 3 KSI at 1350°F. Figure 3 illustrates the creep strength vs. temperature relationship for 304 stainless steel. For a long term installation such as this burner, the 304 stainless material should be limited to 1150°F.

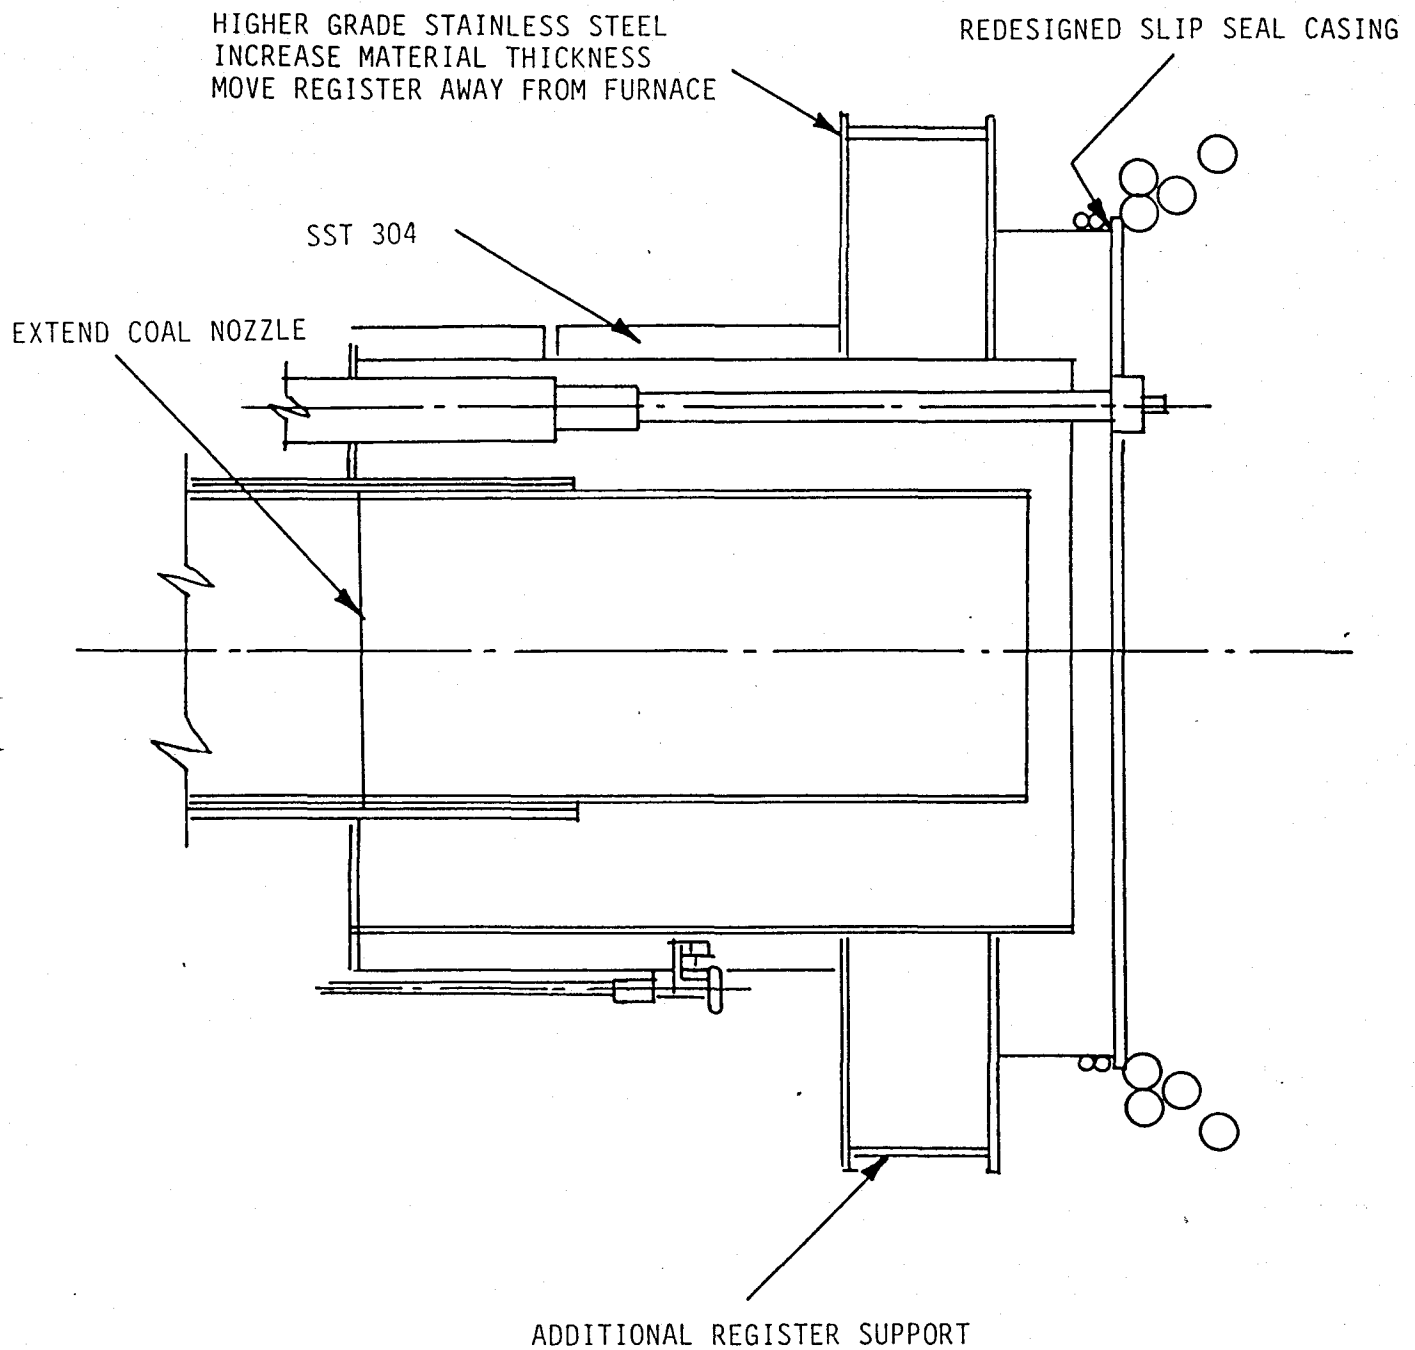
REDESIGNED BURNER
Figure 5

Installing burners that have been redesigned to operate at 1350°F when they are out-of-service is the fourth alternative. The advantages of this alternative are that the boiler efficiency will not be affected and the estimated burner life would be 20-30 years. The burner would remain adjustable which would allow the cooling air flow to be balanced to each of the out-of-service burners. The new burner (see Figure 5) should incorporate the following design changes:

1. The stainless steel material and plate thickness should change on several of the burner components that have failed. This is evidenced by the current HD registers that have been installed in the upper row of burners and have already been permanently warped. A higher grade of stainless steel such as AISI 309 or 310 with a low carbon content would be better suited for high temperatures and welded constructions than a 304 material. This material would provide a higher creep strength and also alleviate long term effects of weld decay (Appendix C). Material thickness would probably also need to be increased on current 309 components to overcome the high stresses that are occurring.

2. The outer register should use the HD register linkage design. This will increase the ability of the register to remain adjustable. Placing the outer register farther back from the furnace should also be considered. This would reduce the amount of heat transfer by radiation and assist in lowering the temperatures of the register back plate and doors. The disadvantage could be the reduction of swirl that is imparted to the secondary air. Considering that the existing burners have good stability while operating with low pressure drop across the burner and severely trimmed register doors, high swirl is evidently not required with the current fuel.

The best alternative to resolve the burner problems that are being experienced at IGS Units 1 & 2 is Alternative #4. Replace the register assemblies with the redesigned one-piece HD style and install new throat sleeve and throat sleeve casings with a new design that will operate at 1350°F. Boiler efficiency will not be affected and estimated burner life should be 20-30 years. The current condition of the existing burners warrant this change because they have a short life expectancy. The following schedule denotes the time required to get the burners installed after a purchase order release.
